Re: City of Rio Rancho Wastewater Treatment Plant #6, Major, Individual Permit; SIC 4952; NPDES Compliance Evaluation Inspection; NPDES Permit No. NM0027987; Inspection Date: August 13, 2019

Compliance Evaluation Inspection Rio Rancho Wastewater Treatment Plant #6 (Internal Outfall into Rio Rancho #2 WWTP) NPDES Permit No. NM0027987 Date of Inspection: August 13, 2019

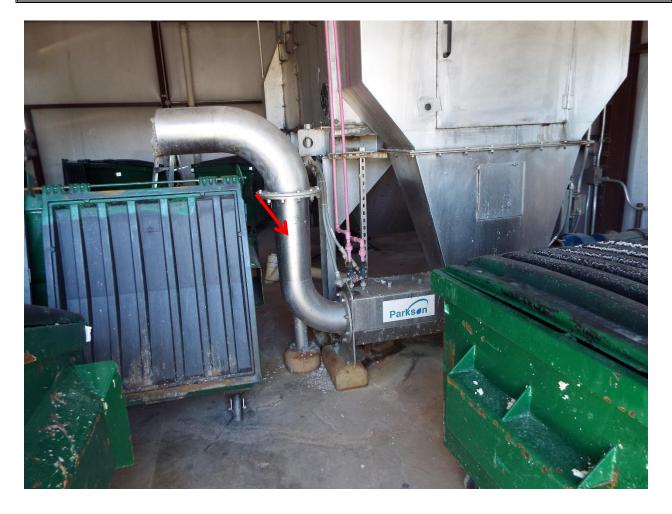
Photographer: Daniel Valenta	Date: August 13, 2019	Time: 1105 Hours		
City/County: City of Rio Rancho / Sa	State: New Mexico			
Location: City of Rio Rancho Wastewater Treatment Plant #6				
Subject: Headworks

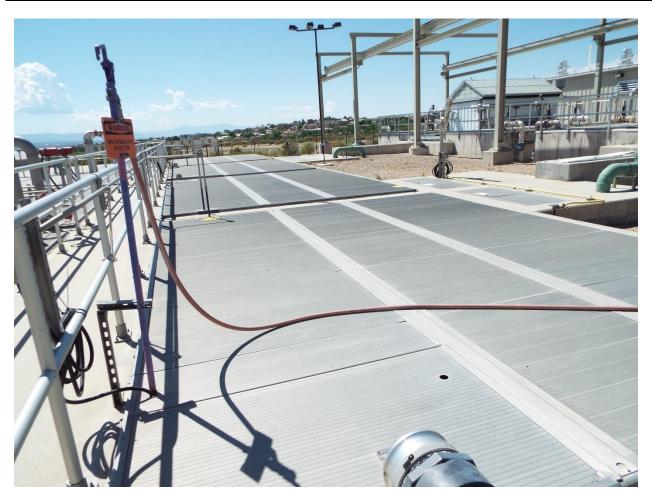
Photographer: Daniel Valenta	Date: August 13, 2019	Time: 1114 Hours		
City/County: City of Rio Rancho / Sandov	ral County	State: New Mexico		
Location: City of Rio Rancho Wastewater Treatment Plant #6				
Subject: Underground MBRs

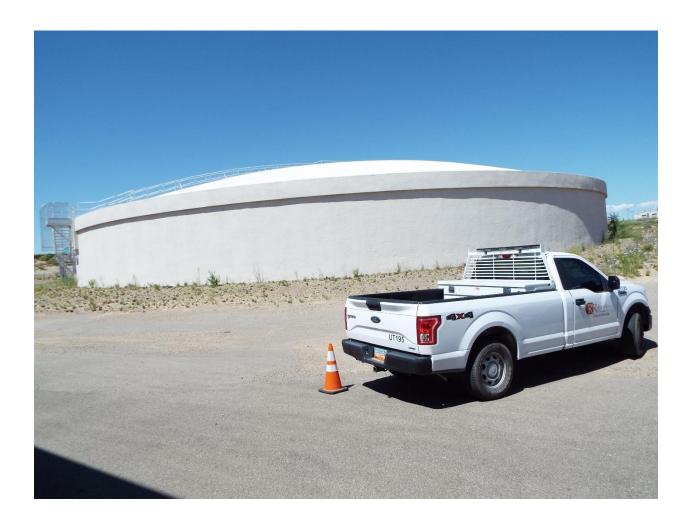
Photographer: Daniel Valenta	Date: August 13, 2019	Time: 1131 Hours		
City/County: City of Rio Rancho / Sandov	al County	State: New Mexico		
Location: City of Rio Rancho Wastewater Treatment Plant #6				
Subject: 3 Million-Gallon Storage Tank

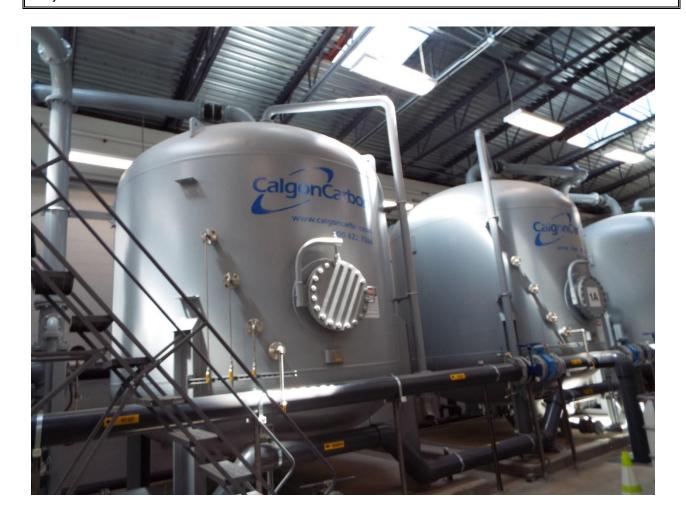
Photographer: Daniel Valenta	Date: August 13, 2019	Time: 1205 Hours		
City/County: City of Rio Rancho / Sar	State: New Mexico			
Location: AWTF				
Subject: Granulated Activated Carbon Tanks

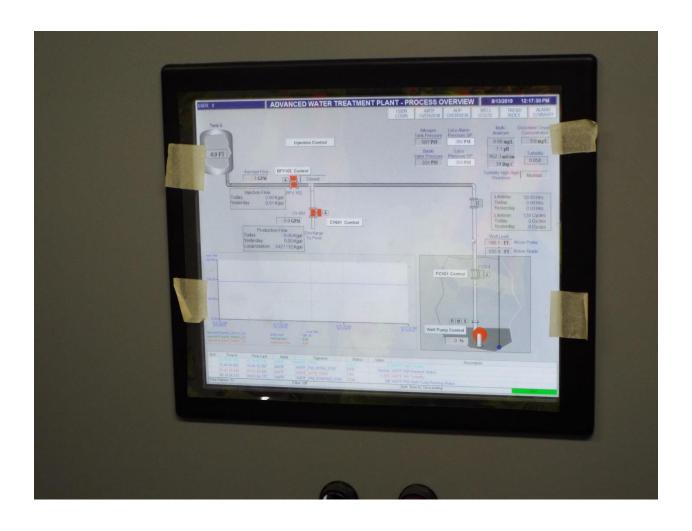
Photographer: Daniel Valenta	Date: August 13, 2019	Time: 1216 Hours		
City/County: City of Rio Rancho / Sandov	ral County	State: New Mexico		
Location: AWTF				
Subject: Overview of AWTF Process
